NASA Technical Memorandum 80226

STRUCTURAL TESTS ON A TILE/STRAIN ISOLATION PAD
THERMAL PROTECTION SYSTEM

Jerry G. Williams

March 1980

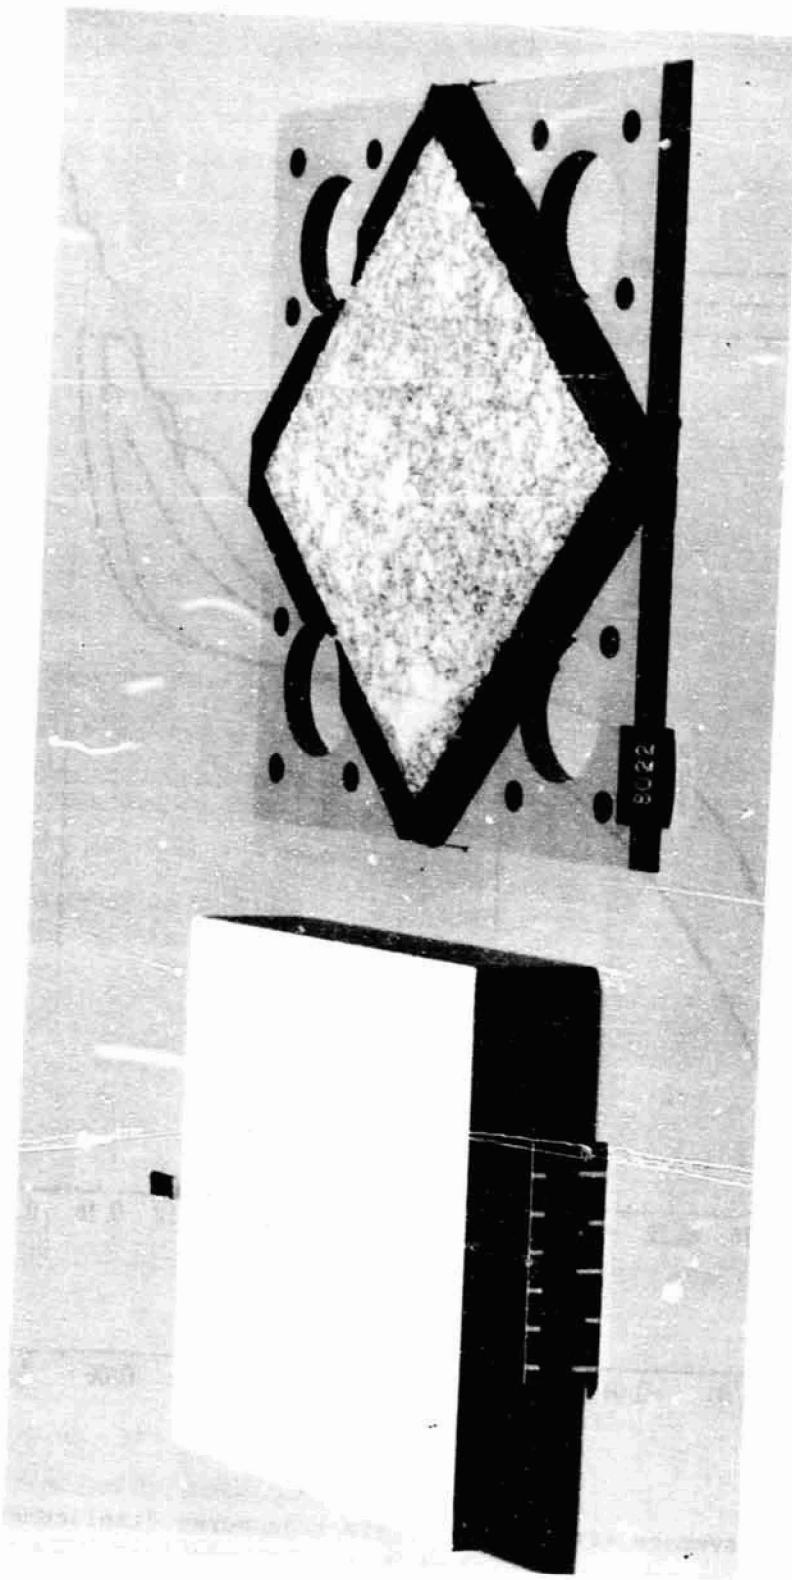
Figure 13. - Failure surface following transverse tension loading of specimen failing proof test acoustic criteria.

The SIP stress versus displacement graph for a specimen which failed the proof test (acoustic emission criteria 3) is presented in figure 12. The initial loading curve is almost identical to that presented in figure 11 for specimens passing the proof test. Also presented is the graph of the second load cycle (permitted under criteria 3) and finally the response for the specimen on the final load cycle to failure. The displacement origin for these plots ignores any permanent set caused by previous loadings. A photograph of the failure surface for this specimen is shown in figure 13.

The failure was in the SIP/tile bond and looks similar to the failure surface of specimens which passed the proof tests and failed during other testing.

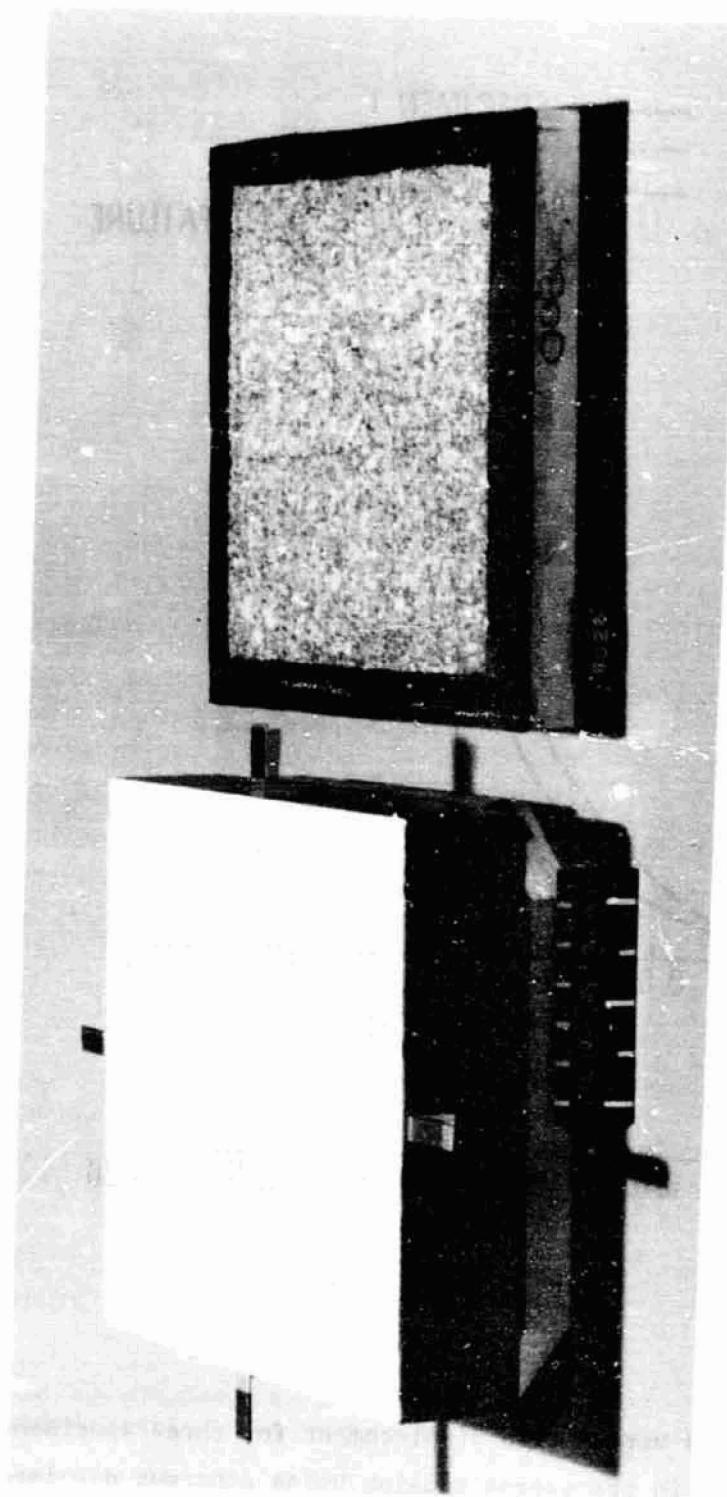
Figure 15. - Failure surface of specimen loaded by transverse tension in constant displacement rate loading machine.

The SIP failure stresses for the three specimens loaded in transverse tension at a constant displacement rate were 63, 73, and 79 kPa (9.2, 10.6 and 11.4 psi), see Table II. The SIP stress versus tile displacement response for these three specimens was similar as seen in figure 14. The failure for these specimens was in the bond between the tile and the SIP as shown for one of the specimens in figure 15. Small particles of the tile became detached and were distributed across the silicone rubber surface.

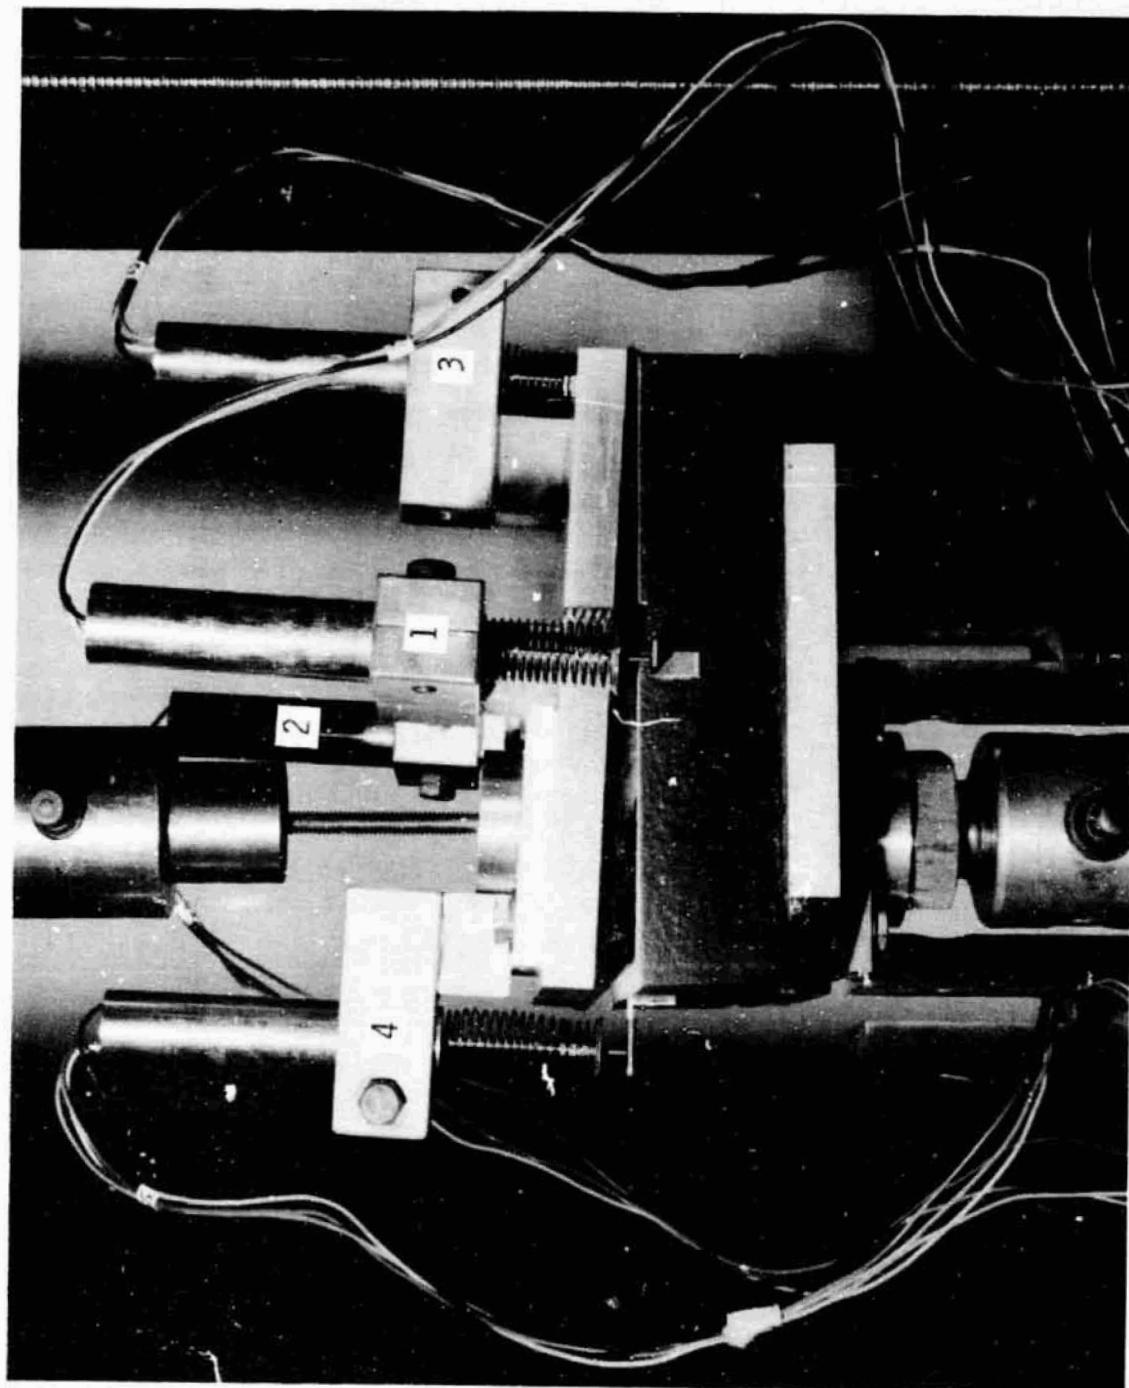
Figure 18. - Photograph illustrating tile rotation and failure in region of maximum stress under eccentrically applied tension loading.

The large rotation of the plate to which the SIP is attached causes the failure to initiate in the region of maximum tensile stress (i.e., in the vicinity of gage 4). A photograph showing the rotation of the plate and disbond failure of the SIP to tile in this region is presented in figure 18 and a

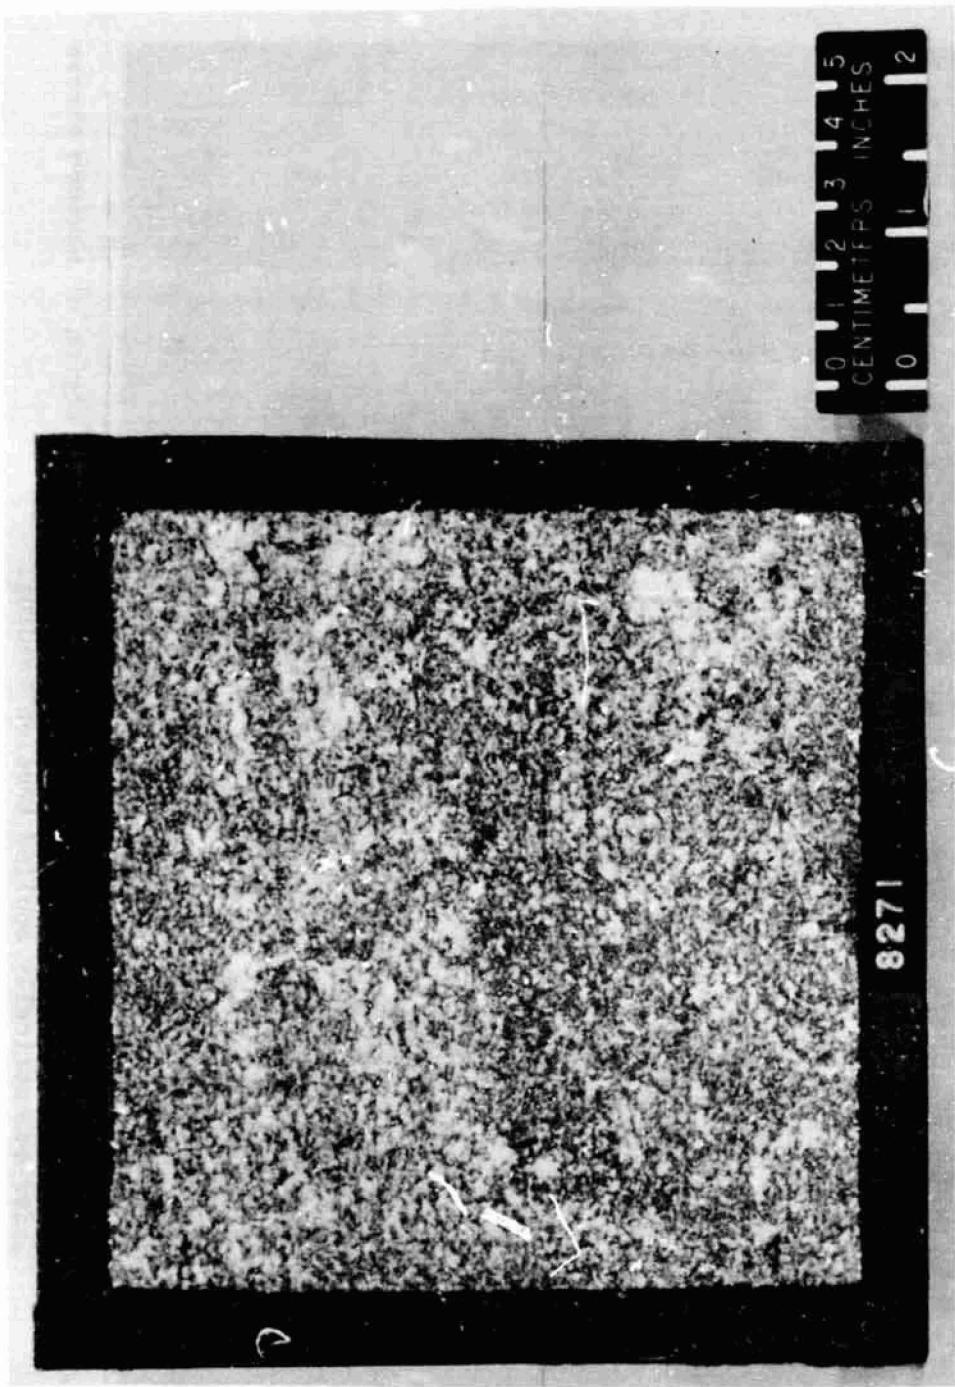
Figure 19. - SIP failure surface of specimen eccentrically loaded by transverse tension.

photograph of the SIP failure surface is presented in figure 19. No distinguishing features were detected in the failure surface and the appearance was similar to that for pure tension tests.

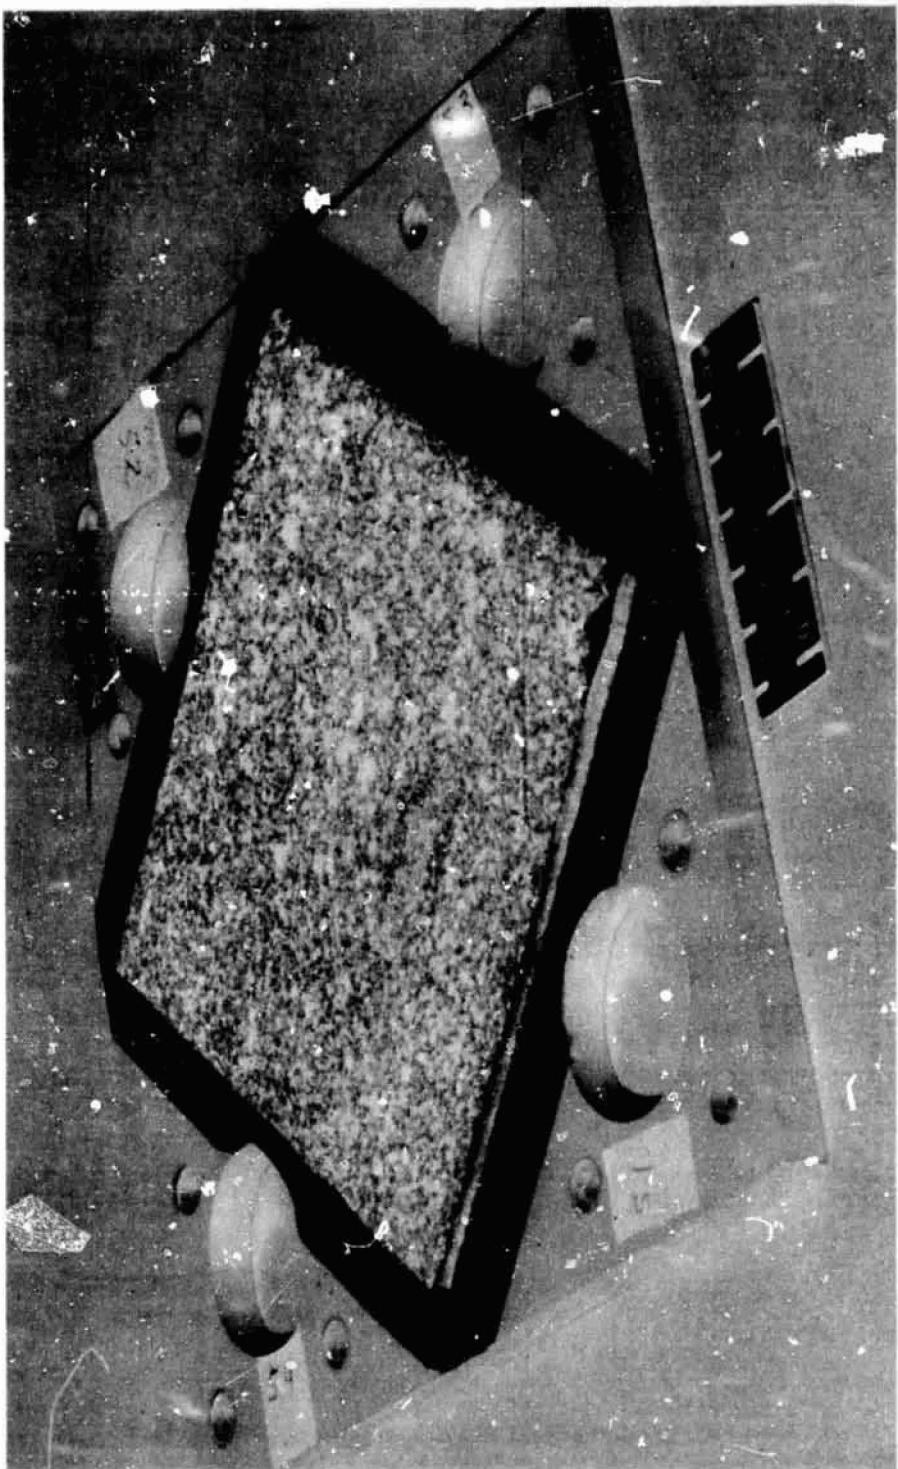
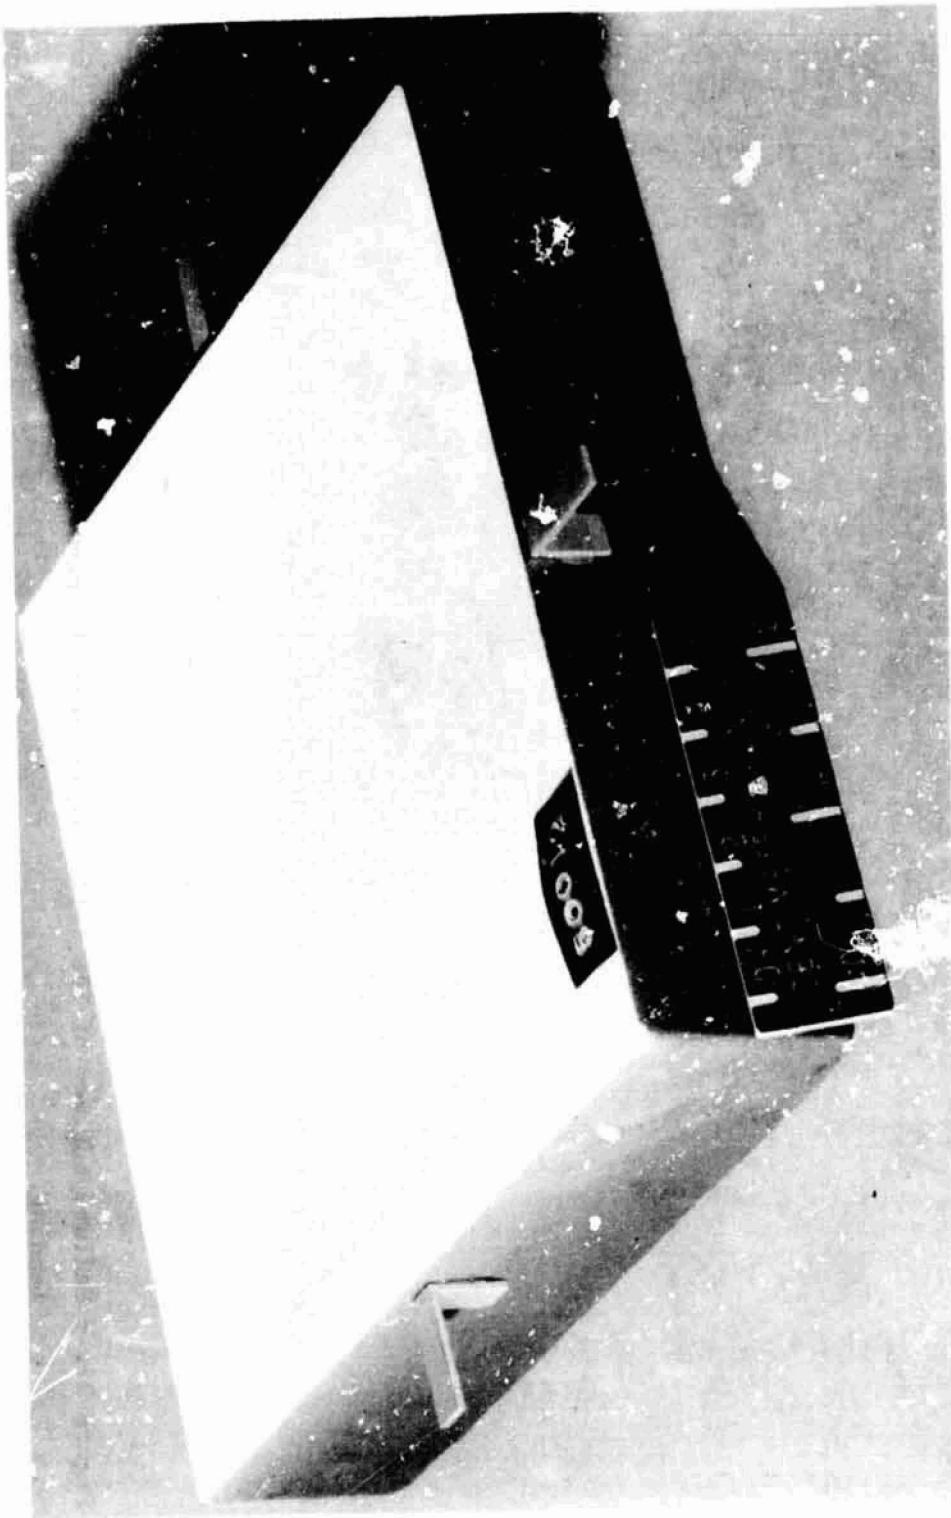
Figure 22. - Failure surface of TPS following combined in-plane and transverse pressure loading.

displacement response for this load cycle is presented in figure 21. The displacement offset at zero load is caused by the in-plane load. Photographs of the SIP and tile failure surfaces are presented in figure 22. No distinguishing appearances were observed compared with failure surfaces observed for other specimens.
